TREE ASSESSMENT REPORT

BOYD LAKE HOLDINGS C/O LAND ASSET
STRATEGIES | ATTN: BOB ECK

LAKEVIEW

December 9, 2022

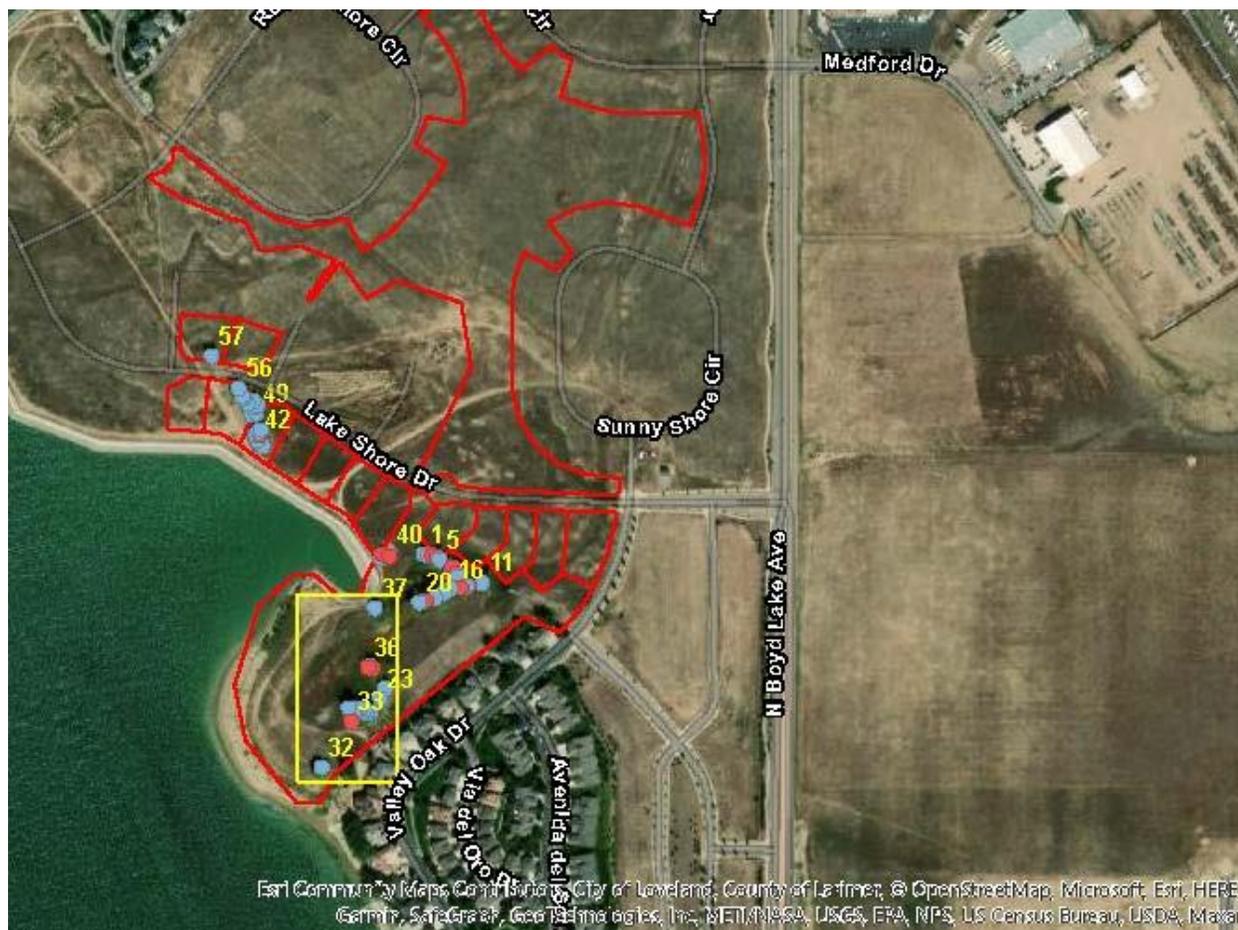
Figure 1 – Site map. The yellow rectangle represents the same area as illustrated in the supplied document Lake View -Tree Inventory Exhibit-notes.pdf. “It is likely that we will be able to retain these trees.”

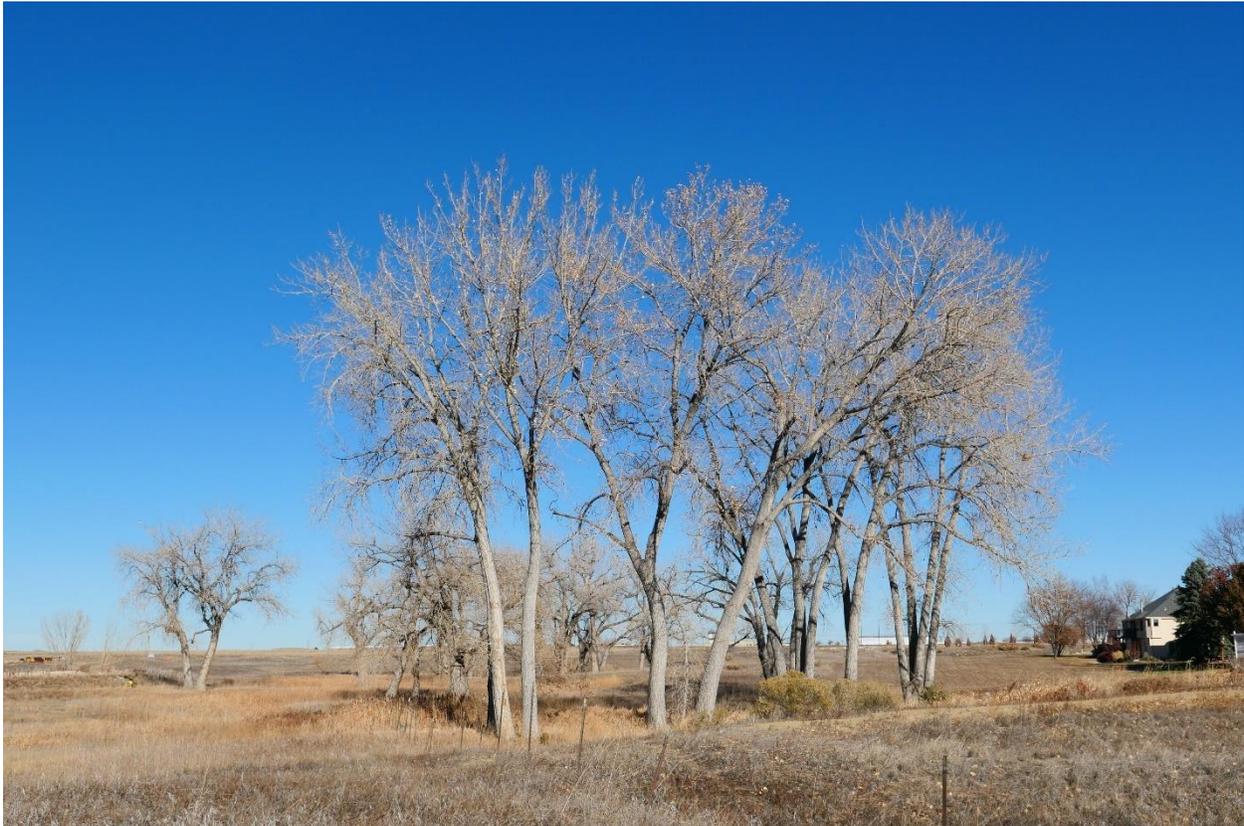
Photograph 1

It should be noted that the trees in poor condition are not candidates for retention. All 16 trees in poor condition also possess structural deficiencies resulting in an elevated tree risk rating.

These trees are within the yellow box found in the site map (Figure 1) and could be retained. In this group, trees 21, 33, 35, and 36 are in poor condition and should be removed.

We were provided with the document *Lake View – Tree inventory Exhibit-notes.pdf*. This document has a rectangle drawn on it with a note that these trees will likely be retained. Using this, we presumed that the trees within this rectangle would be retained (retain) and the other trees removed (remove) for development purposes. Within this rectangle, 4 trees were deemed to be in poor condition with structural deficiencies. We opine that these 4 trees (21, 33, 35, and 36) should be removed.

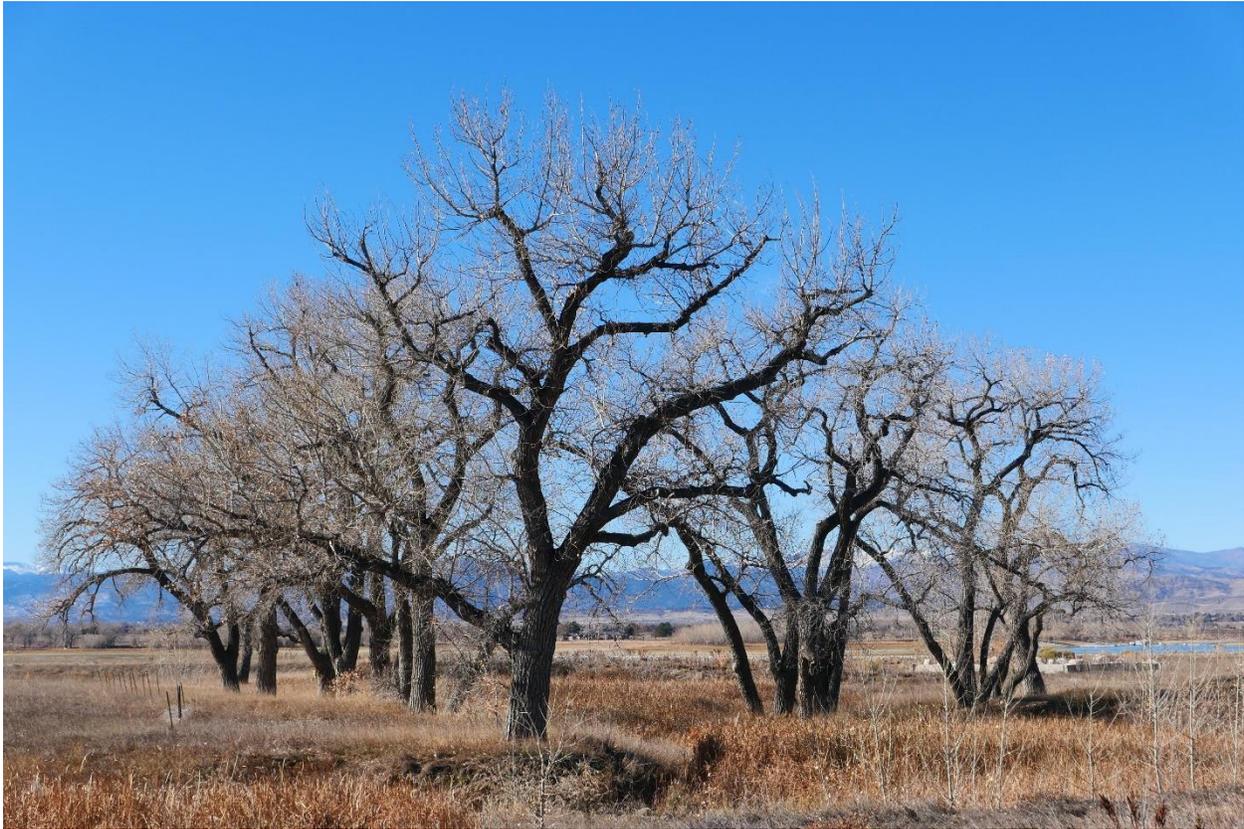
Photograph 2

This group of trees will need to be removed to facilitate development of this site.
