COLORADO CULTURAL RESOURCE SURVEY

Architectural Inventory Form

- 1. Resource number: **5LR.6745**
- 2. Temporary resource no.: **N/A**
- 3. County: **Larimer**
- 4. City: **Loveland**
- 5. Historic building name: **Swartz Farmhouse**
- 6. Current building name: **Swartz Farmhouse**
- 7. Building address: **715 S. Railroad Avenue**
- 8. Owner name and address: **City of Loveland
500 E. 3rd Street
Loveland, CO 80537**

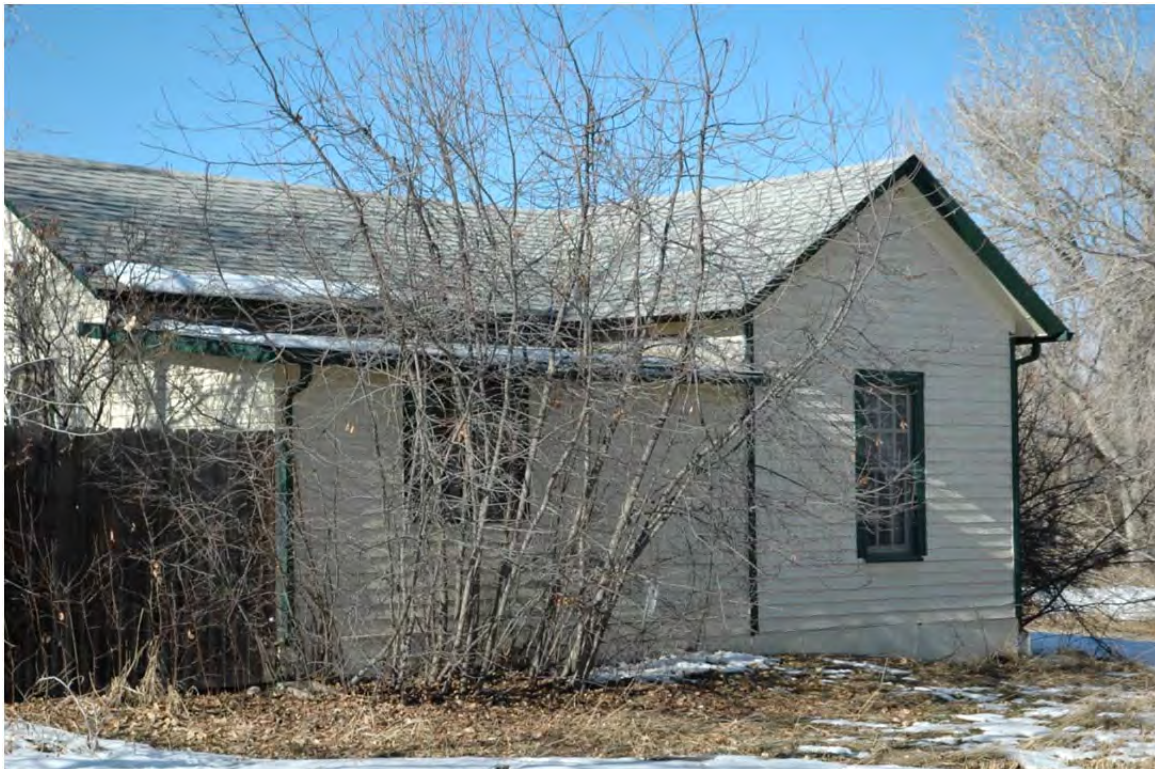
This 1 $\frac{1}{2}$ -story wood frame building is composed of four elements: an original L-shaped, cross-gabled dwelling, which overall measures 29 $\frac{1}{2}$ ' N-S by 22' E-W; an enclosed shed-roofed section, which measures 17 $\frac{1}{2}$ ' N-S by 6' E-W, and fills in the void formed by the original building's L-shape, at the south end of the east elevation; a gabled extension to the west elevation, which measures 20' N-S by 24 $\frac{1}{2}$ ' E-W; an enclosed hipped-roof mud porch addition on the west elevation, which measures 18' N-S by 6 $\frac{1}{2}$ ' E-W. The original house is covered by a low sandstone foundation covered with painted cream yellow concrete pargeting. There is no basement. The exterior walls are clad with painted cream yellow horizontal wood siding, with painted green 1" by 4" corner boards, except the south elevation of the gabled extension which is clad with a red brick veneer laid in running bond. The gabled and shed roofs are clad with grey asphalt composition shingles, and the eaves are boxed with painted cream yellow and green wood trim. Two painted green wood-paneled doors, each with nine upper sash lights and each covered by a white metal screen door, enter the south elevation from an uncovered concrete patio/porch which measures 12 $\frac{1}{2}$ ' N-S by 30' E-W. One of these doors enters the gabled extension, while the other enters the south end of the hipped-roof mud porch. All windows feature painted cream yellow wood frames and painted green wood surrounds. Window patterns include 6/6 double-hung sash, 6-light hoppers or casements, and single-light fixed-panes.
