City Council Staff Report

From: Matt Robenalt, Long Range Planning Division
Meeting Date: December 16, 2003
Re: Application for Designation as a Historic Landmark Property

Address: 201 E. 4th Street, Loveland, Colorado

Historic Name: First National Bank Building

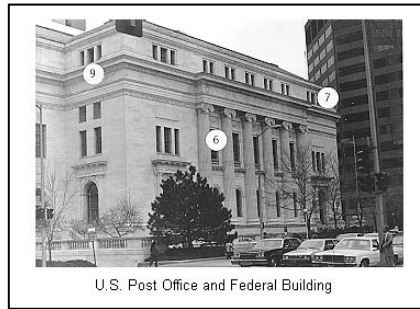
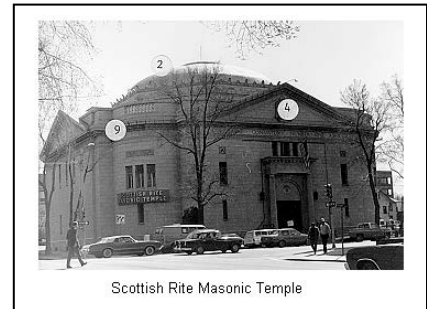
Photos #1 (left), #2 (center), and #3 (right). Examples of Classic Revival architecture. Source: Colorado Historical Society Guide to Colorado's Historic Architecture, 1983.

The First National Bank building is an example of the Classical Revival style of architecture. The Colorado Historical Society Guide to Colorado’s Historic Architecture and Engineering identifies Classical Revival architecture as a return to the classical forms of Greece and Rome following the elaborately decorated and picturesque styles of the Victorian period. Typically dating from the late 1890s through 1920, Classical Revival represents a more refined stage of the “Beaux Arts” tradition, and is evident mainly on large institutional buildings in Colorado. The “Beaux Arts” is a term applied to a style of classical architecture found particularly in France and the U.S.A. that is derived from the academic teaching of the Ecole des (school of) Beaux-Arts, Paris, during the 19th and early 20th centuries. The style is characterized by its formal planning and rich decoration, which typically includes features such as colossal porticos, large columns, pilasters, pedimented windows, and domes. The buildings are generally masonry structures of monumental proportions, using terra cotta, brick, and stone materials. See Photos #1, #2, and #3 for examples of Classical Revival architecture in Colorado.

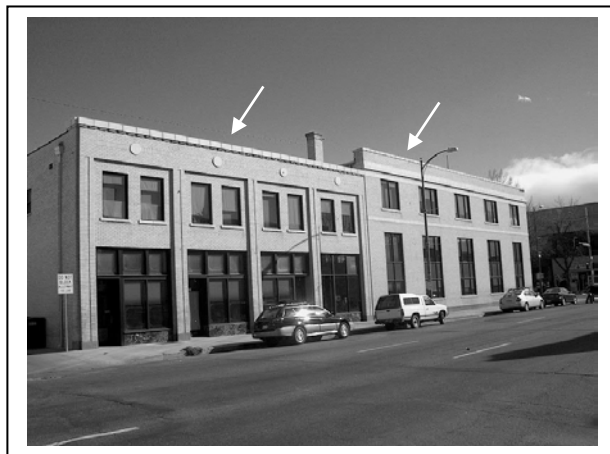
The First National Bank building is a two-story structure, constructed of buff-colored brick. The building is rectangular in form, and is composed of two (2) parts: a main front block (80 ft. long) and a rear-block of lower height (55 ft. long). See Photo # 4 and Photo #5.

Photo #4. West elevation shows front-block, and lower height rear-block.

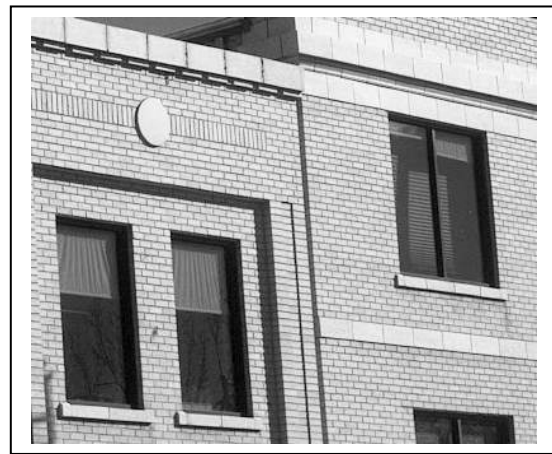
Photo #5. Primary building material is buff-colored brick.

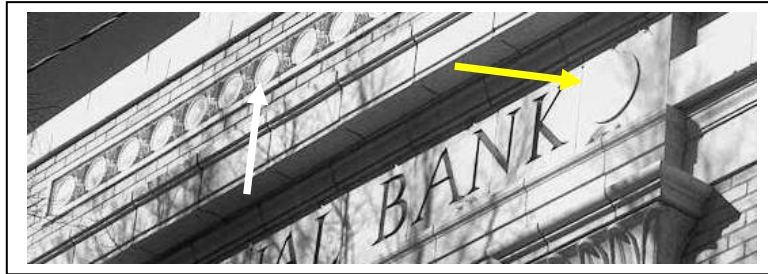
Photo #9. Main façade medallions.
