### Loveland City Council Staff Report

From: Matt Robenalt, Community and Strategic Planning  
Meeting Date: July 5, 2005  
Re: Application for Historic Landmark Property Designation

**Request:** Application for Historic Landmark Property Designation

**Historic Name:** Swan House

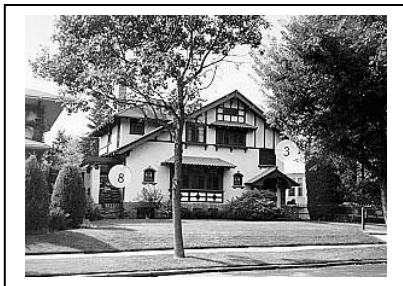
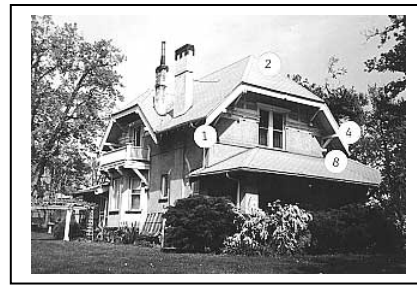
**Photo # 1 & #2.** Examples of Craftsman Style. Source: Colorado Historical Society Guide to Colorado’s Historic Architecture and Engineering, Second Edition 2003.

- 1. exposed rafter ends
- 2. clipped gable
- 3. half-timbering
- 4. knee braces at eaves
- 5. divided upper window lights
- 6. large porch columns
- 7. soffit return underside rafter ends
- 8. overhanging eaves

Examples of Craftsman style architecture are provided in Photos #1 and #2.

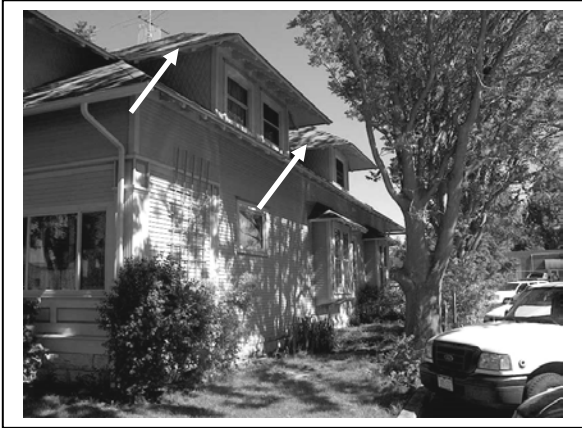
**Photo #3.** Two of six hipped-roof dormers. These are located on the east elevation.

west end of the north (rear) elevation which comprises an enclosed rear porch and is clad with bead board. The dwelling is covered by a moderately-pitched hipped roof, covered with black asphalt composition shingles. Decoratively sculptured wood rafter ends are exposed beneath wide overhanging eaves, and there are two red brick chimneys on the roof ridge. There is a total of six hipped-roof dormers, including one on the facade, two each on the east and west elevations, and one on the north elevation. See Photo #3, Photo #4 and Photo #5.

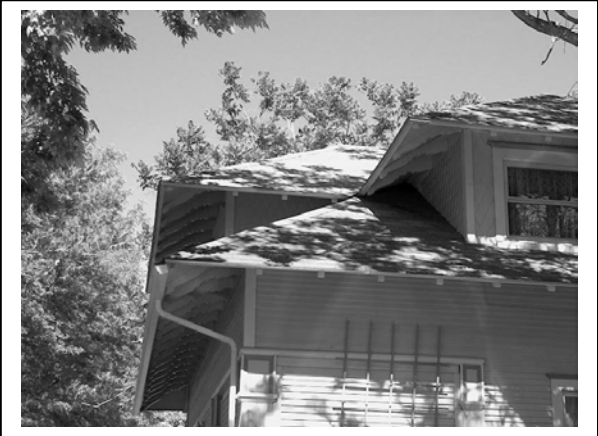
**Photo #4.** Wide overhanging eaves are featured on the main hipped-roof, and dormers.

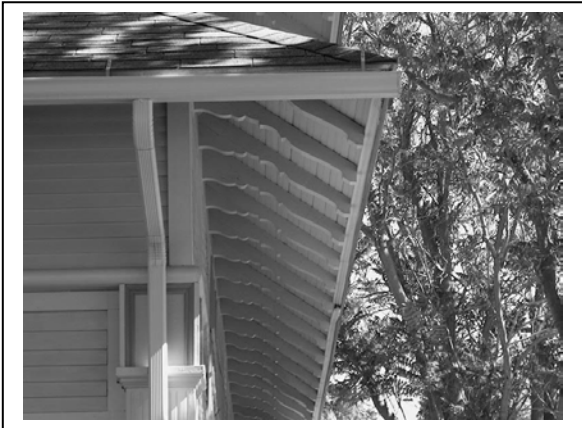
**Photo #5.** Sculptured wood rafters beneath wide overhanging eaves.

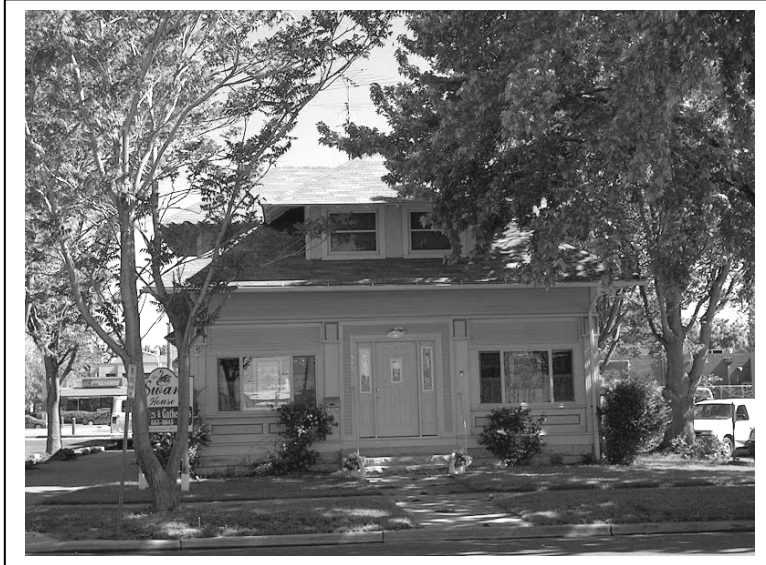
**Photo #6.** Front elevation with squared columns and enclosed front porch.

The dwelling’s symmetrical facade comprises an enclosed front porch set beneath the large hipped-roof dormer. Two single-light fixed-pane windows, with horizontal sliding sidelights, flank the front entry door. The entry is flanked by two squared columns. Two additional sets of squared columns also appear at either end of the enclosed porch. See Photo #6.

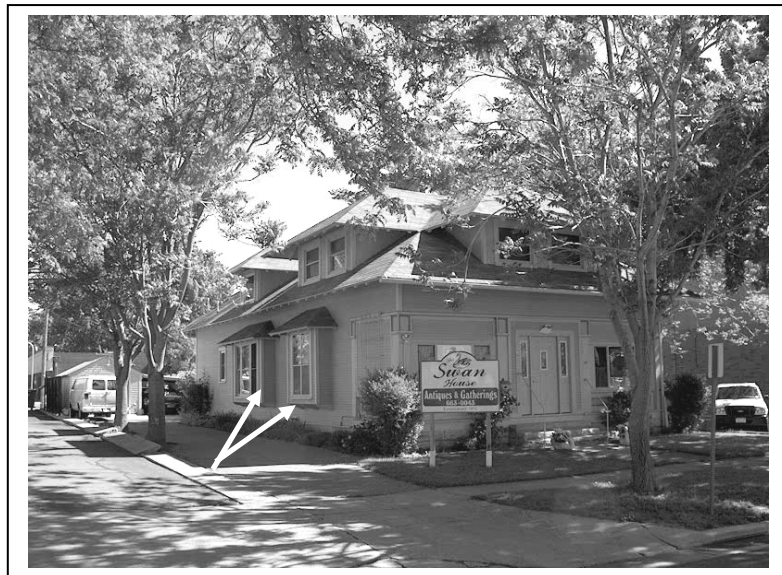
**Photo #7.** West elevation with boxed bay windows.

All of the home's windows have painted beige wood frames and surrounds. Windows on the building's east elevation include a single-light fixed-pane window, a boxed bay with two 1/1 double-hung sash windows, a single 1/1 double-hung sash window, and another boxed bay with two 1/1 double-hung sash windows. Windows on the west elevation include a boxed bay with a large 1/1 double-hung sash window, another boxed bay with one 1/1 double-hung sash window flanked by two narrow 1/1 double-hung windows, and one single 1/1 double-hung sash windows. See Photo #7.

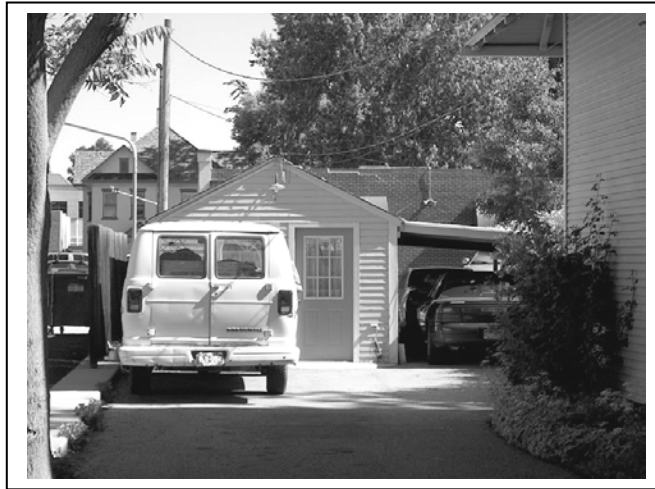
**Photo #8.** Former garage located at the northwest corner of the property.

The former garage has been converted into a workshop, and measures 20 feet north-south by 12 feet east-west. It is of wood frame construction, and is supported by a poured concrete slab foundation and floor. Its exterior walls are clad with painted beige and white horizontal wood siding. The storage shed abuts the north (rear) elevation of the former garage. It is of wood frame construction, and measures 12½-feet north-

south by 12-feet east-west. It has a wood timbers on grade foundation, and painted white horizontal exterior wood siding. See Photo #8.
