Environmentally Sensitive Areas Report for Lakeview Development

January, 2023

1.0 INTRODUCTION

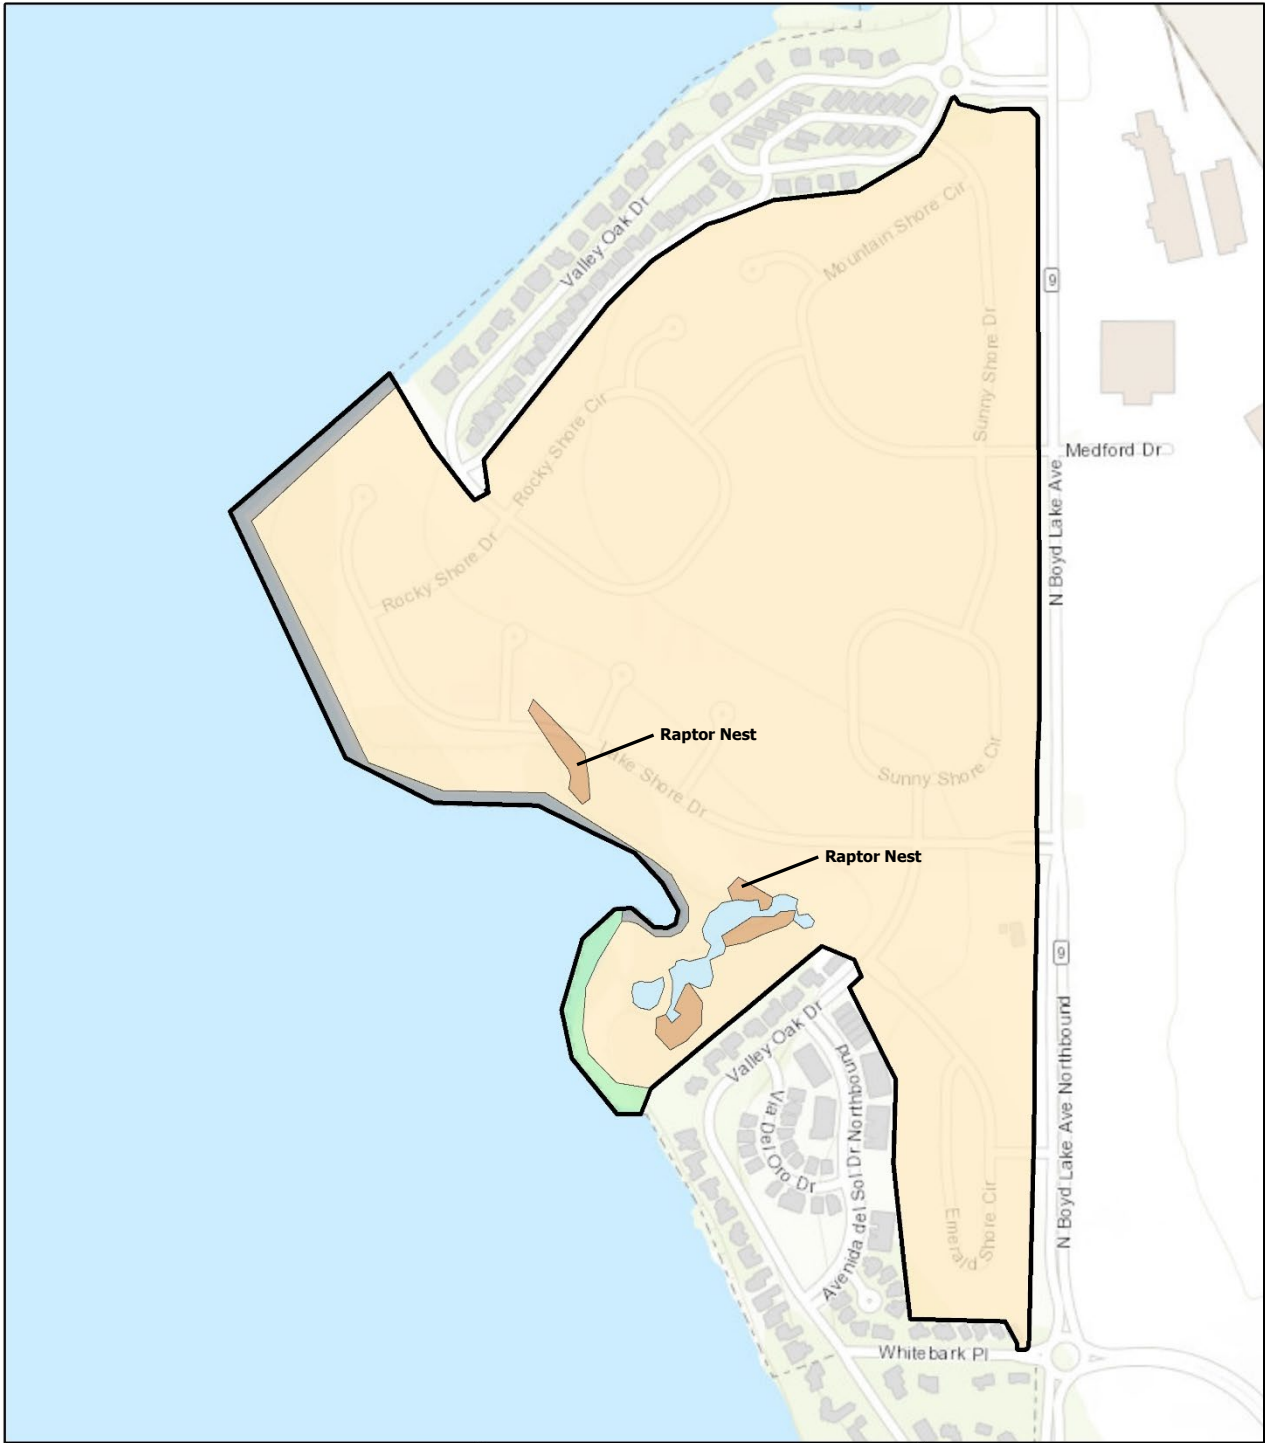
<p>Legend</p> <p>Habitat</p> <ul style="list-style-type: none"> Mature Trees Rockarmored Shore Upland Grassland Vegetated Slope Wetland <p> Property Boundary</p>	<p>Lakeview Development</p>
<p>Coordinate System: State Plane</p> <p>Sources: Cedar Creek</p>		<p>Figure 2: Project Habitats</p>

Figure 2 shows that there are three habitats identified within the study area: upland grassland (146.7 acres), wetland/riparian (1.3 acres), and mature tree groves (1.6 acres), the remaining acres are associated with the rock armored and vegetated bank slopes of Boyd Lake. Most of the study area consists of the grassland habitats that are dominated by non-native grasses and forbs, such as smooth brome (*Bromus inermis*), western wheatgrass (*Pascopyrum smithii*), crested wheatgrass (*Agropyron cristatum*), and upland associated annual weeds such as Canada thistle (*Cirsium arvense*) or burningbush (*Bassia scoparia*), which are frequently disturbed through grazing and occasional mowing.

The U.S. Army Corps of Engineers (USACE) requires evidence of three hydric parameters (hydric soils, wetland hydrology, and wetland vegetation) to be exhibited in an area for it to qualify as wetland. Evidence of all three wetland parameters was found along the unnamed drainage (Figure 2). At this time, a formal wetland report has not been prepared for the U.S. Army Corps of Engineers (USACE).

According to the NRCS soils mapping, aquepts soils make up 7.6% of the project site and are classified as hydric soils. Their natural drainage is poor or very poor and if the soils have not been artificially drained, ground water is at or near the soil surface at some time during normal years. On the project site, these soils are associated with the wetlands that have been delineated. Wetlands supported within the stormwater drainage may be jurisdictional since the drainage has continuous hydrologic connection to Boyd Lake. However, wetlands are not continuous along the stormwater drainage channel, nor does it exhibit continuous characteristics (defined bed and bank) of a Waters of the United States channel along its length within the study area. Wetlands in the southern portion of the property have developed in relatively shallow drainage basins that collect surface water runoff from adjacent uplands (see Figure 2). No defined, unvegetated channels are present in these drainages.

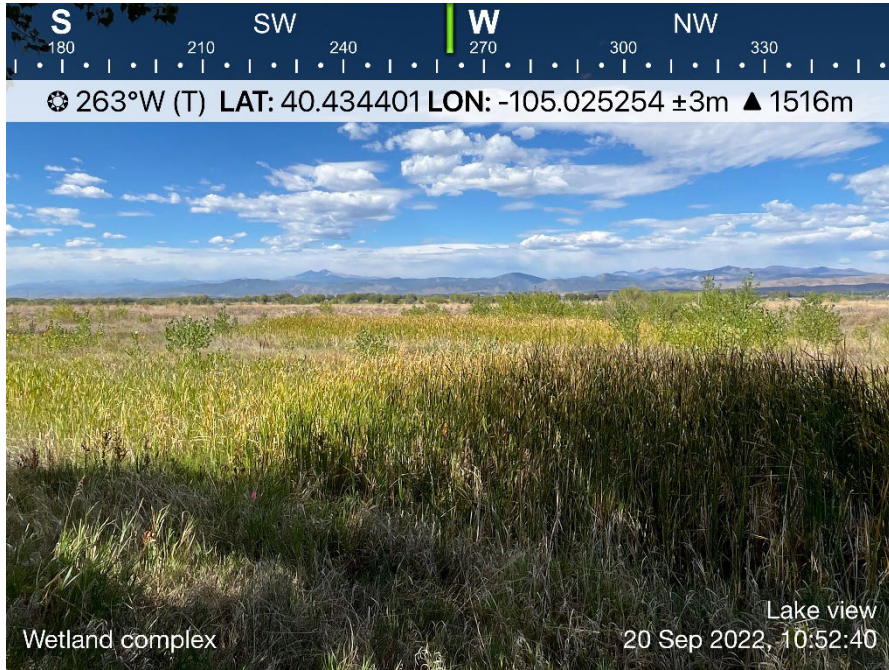
Photograph 1. Wetland complex.

- The delineated wetlands within the project area are likely jurisdictional because of the connectivity to Boyd Lake. These should be protected with a 50-foot buffer.

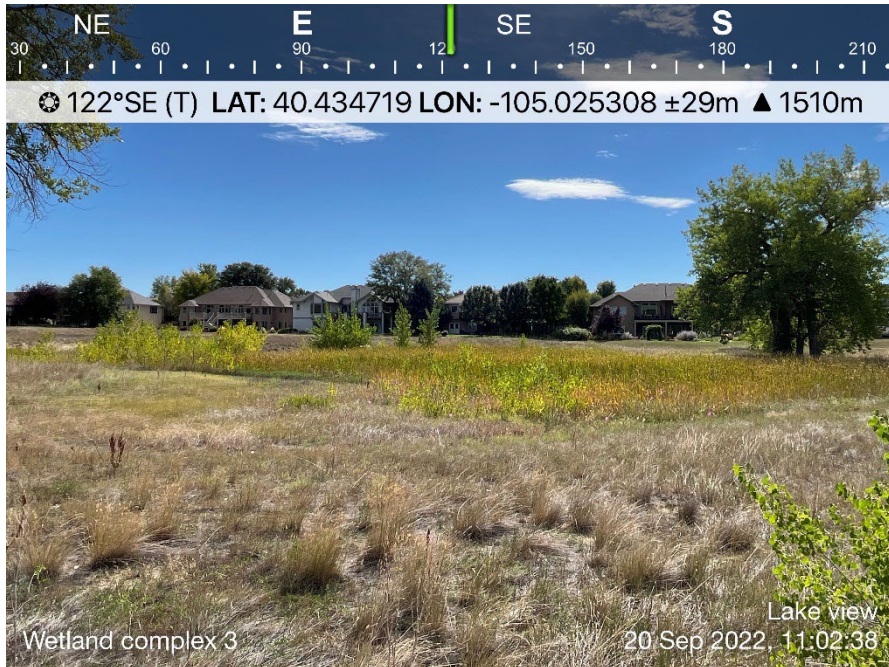
Photograph 4. Wetland complex with mature trees.

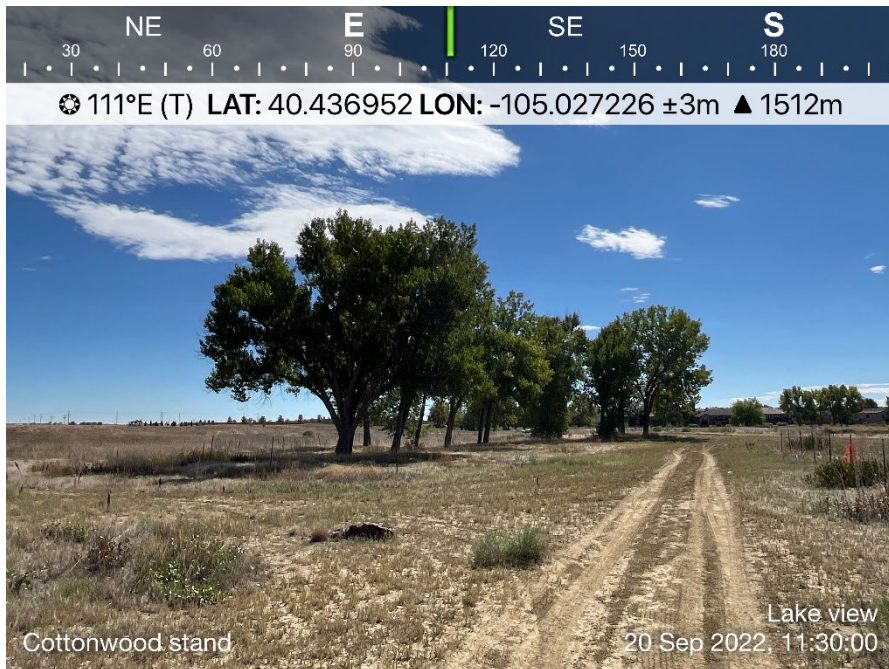
A red-tailed hawk was observed vocalizing and defending a nesting structure in a cottonwood tree surrounding the south wetland complex during the September field survey. This nest status was undetermined due to the survey timing; however it is likely active that year evidenced by down feathers and prey remains that were observed in the vicinity of the nest. Another small, inactive stick nest was observed in the other mature cottonwood stand on the property. Future raptor nesting in trees within the project site is likely due to proximity to Boyd Lake and lack of availability of surrounding suitable nesting habitat. No active prairie dog colonies were observed throughout the upland portion of the project area.

Photograph 6. Mature tree grove with raptor nest.

- With the presence of habitat for migratory birds and raptors, it is suggested that pre-clearance survey be conducted if ground-disturbing activities are planned during the breeding and nesting seasons. Should active nests be found, the Colorado Parks and Wildlife buffer guidance should be used.

- To the extent practicable, the mature tree supporting the potential active raptor nest adjacent to the wetland should not be removed.

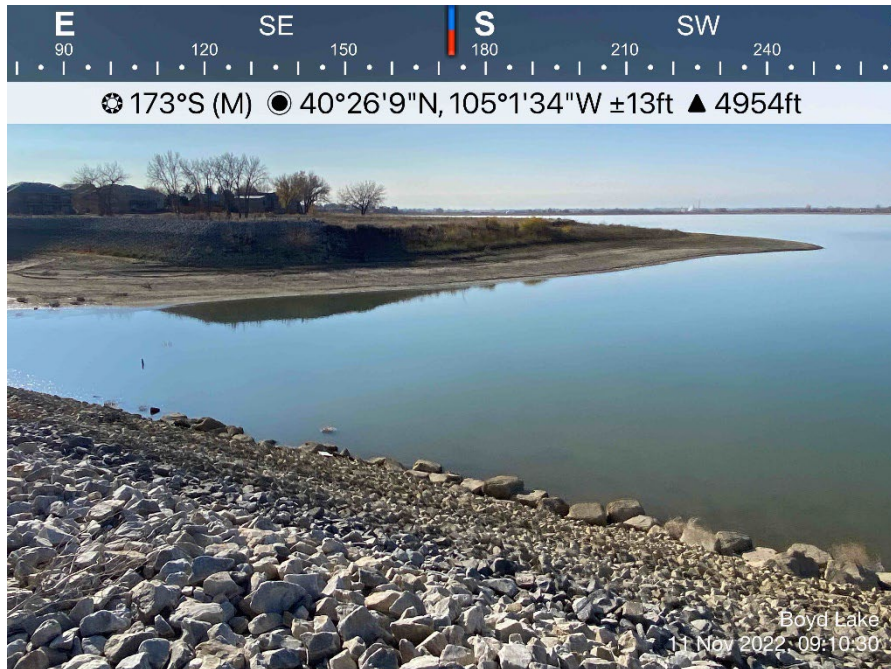
Photograph 10. Vegetated banks of Boyd Lake.

2. Vegetated Banks – The vegetated banks along the southern portion of the property are currently degraded but could provide valuable cover and habitat for urban adapted wildlife species if restored. In addition, this area provides a connection between the wetland habitats and Boyd Lake. Therefore, a buffer of 100 feet should apply from the ordinary high-water mark of Boyd Lake (at capacity) to protect this higher value shoreline habitat. Ecological restoration of the buffer area should be considered.
